LOOKING BACK AT THE COCOANUT GROVE

On the night of November 28, 1942, fire swept through Boston's most popular night club, the Cocoanut Grove. In less than 30 minutes, the fire had traveled through the four main rooms, leaving 492 persons dead or dying. The magnitude of the tragedy was unparalleled in the United States and led to extensive investigations into its causes. These investigations not only revealed the technical causes of the fire and huge loss of life, but also hinted at a more deeply rooted problem: fire codes and their enforcement.

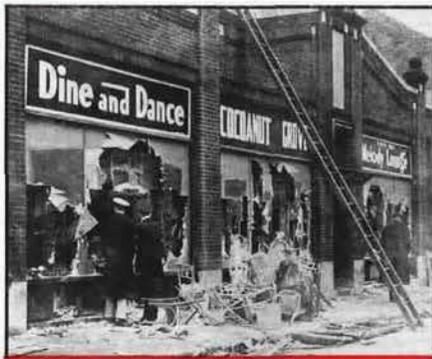
Above: The Shawmut Street side of the Cocoanut Grove the morning after the fire. The center door, which was partially opened during the fire, served as the emergency exit for many on the first floor.

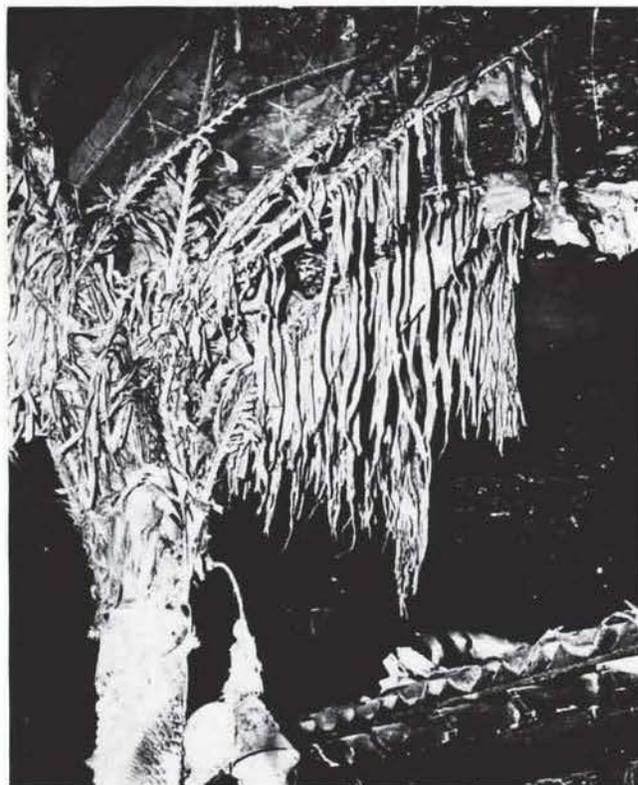
In the Melody Lounge, a young busboy lit a match to provide light while he replaced a fixture in an imitation palm tree. After fixing the light, he extinguished the match. A few moments later, someone noticed that the palm tree was on fire. Although the bartenders tried to extinguish the flames, the fabric ceiling was soon burning. The fire quickly spread along the entire ceiling of the Melody Lounge.

One of the few artificial palms remaining in the Coconut Grove after the fire. Wiring was concealed in the foliage. NEPA
