CITY OF BOSTON

FIRE DEPARTMENT

In accordance with Section 3 of Chapter 148 of the General Laws, (Ter. Ed.), of the Commonwealth of Massachusetts, I submit herewith a report of an investigation into the circumstances of the fire which occurred at the Cocoanut Grove, 17 Piedmont Street, Boston, Mass., on November 28, 1942, which fire resulted in 490 deaths and 166 injuries, as recorded by the Boston Committee on Public Safety.

DESCRIPTION OF PREMISES

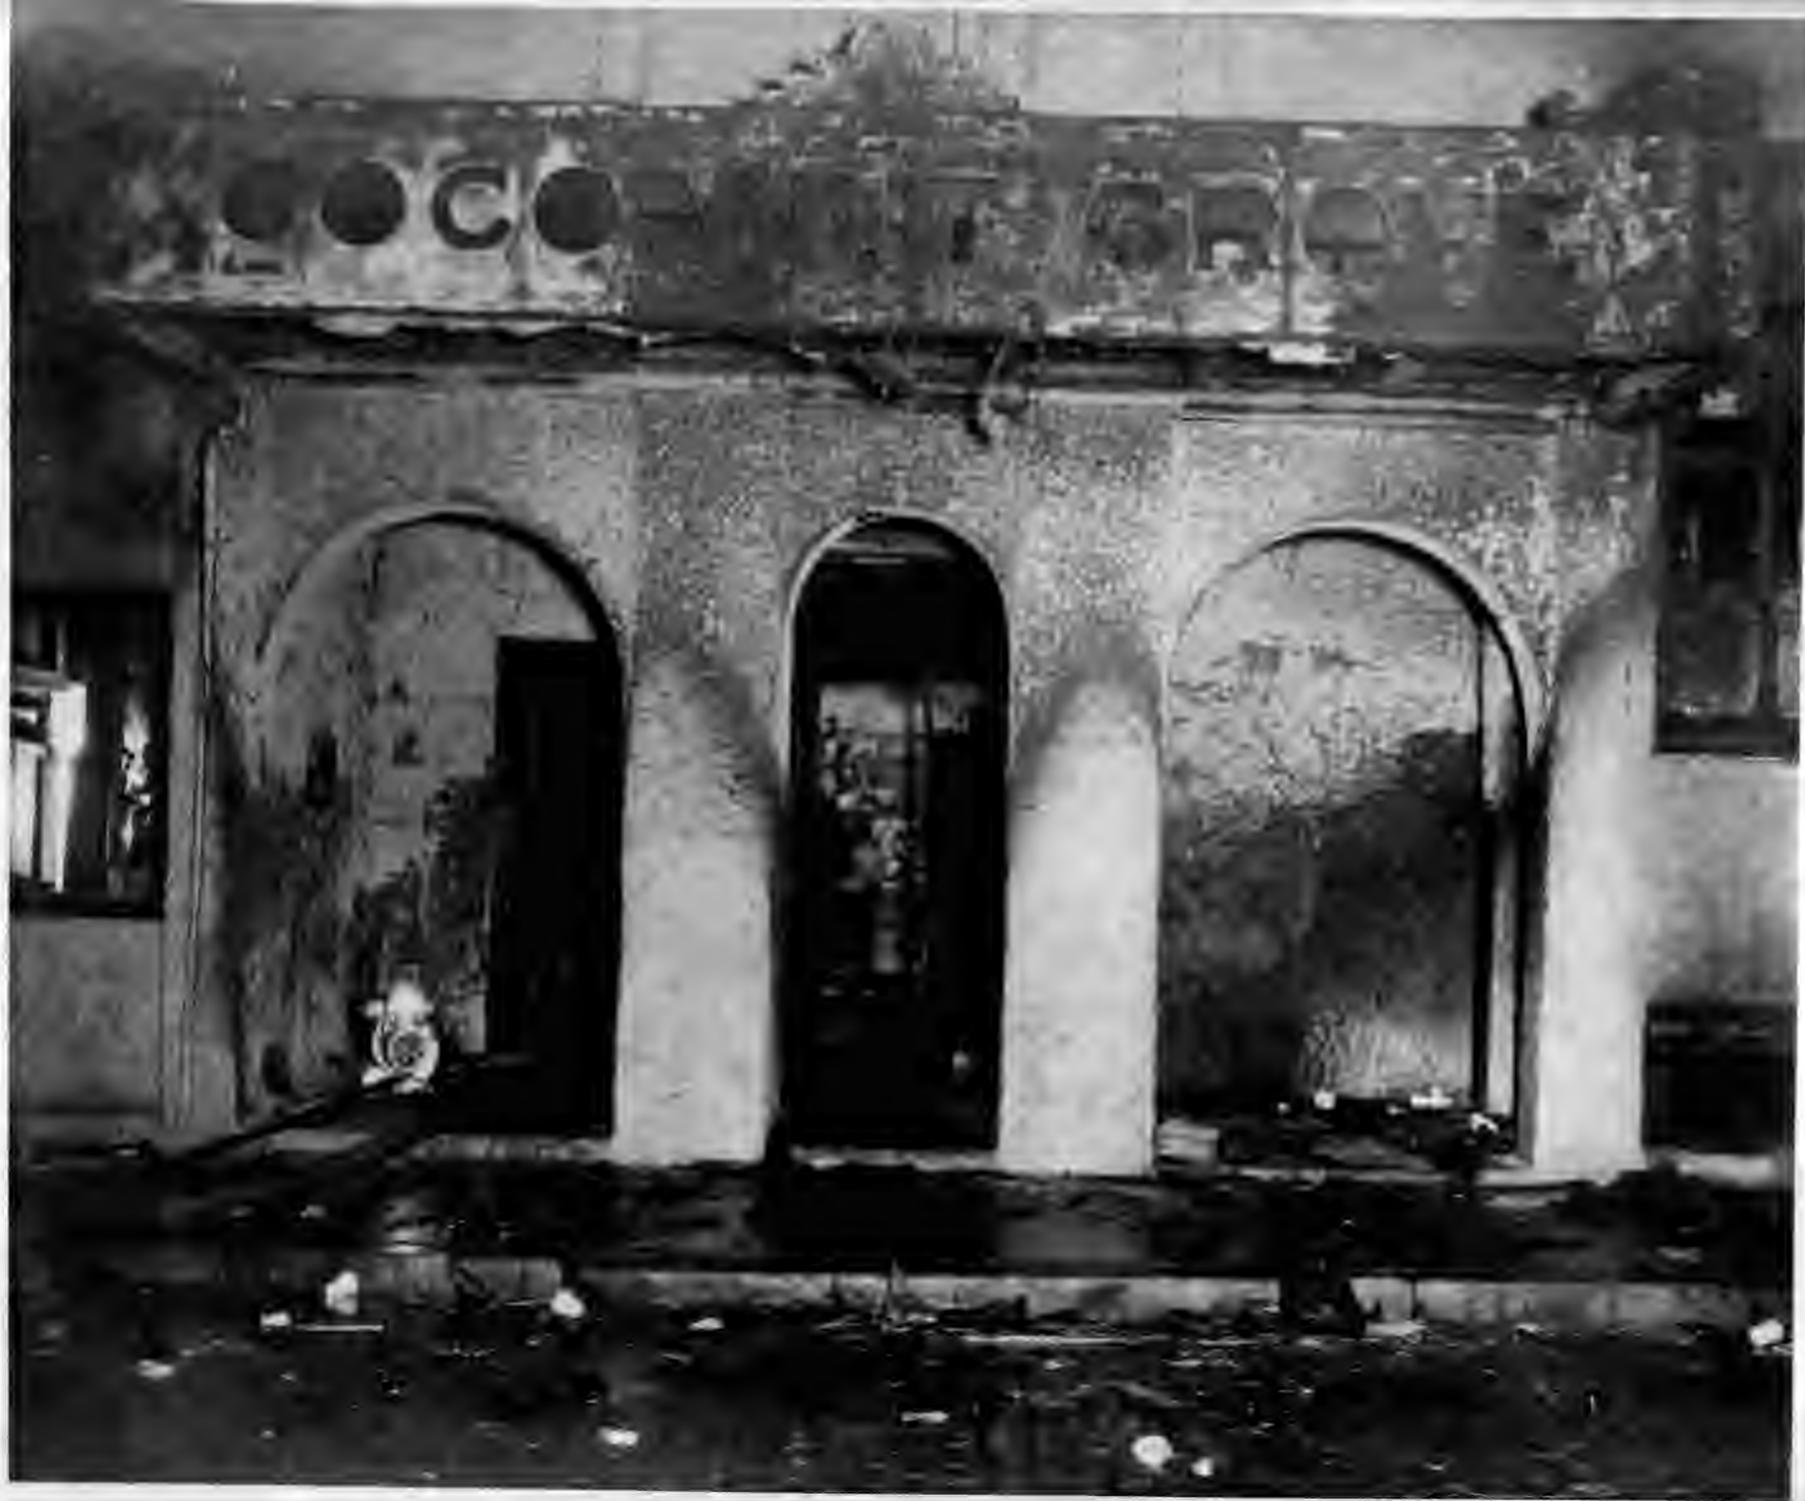
The main entrance was at 17 Piedmont Street, a narrow street of about 21 feet in width (from curb to curb).

The entrance door was of a revolving type recessed from the sidewalk in a portico about 18 feet wide and 9 feet in depth. (See photograph attached, taken after the fire).

To the left of the revolving door, (as one enters from the street), was a door leading in to the check room and office. (This door was not used the night of the fire, this section being used as a check room). The window to the left of the portico was also in this coat room and office.

The window to the right of the portico was one of those in the rear of the service bar. The basement window on the right of the portico led into the storage room of the basement.
